UNDERWATER FACILITIES  
INSPECTION &  
ASSESSMENTS  
NAVAL STATION CHARLESTON, SC.

The objective of the underwater facility assessments conducted at the U.S. Naval Station in Charleston, South Carolina is to provide a generalized structural condition report of designated facilities within the activity.

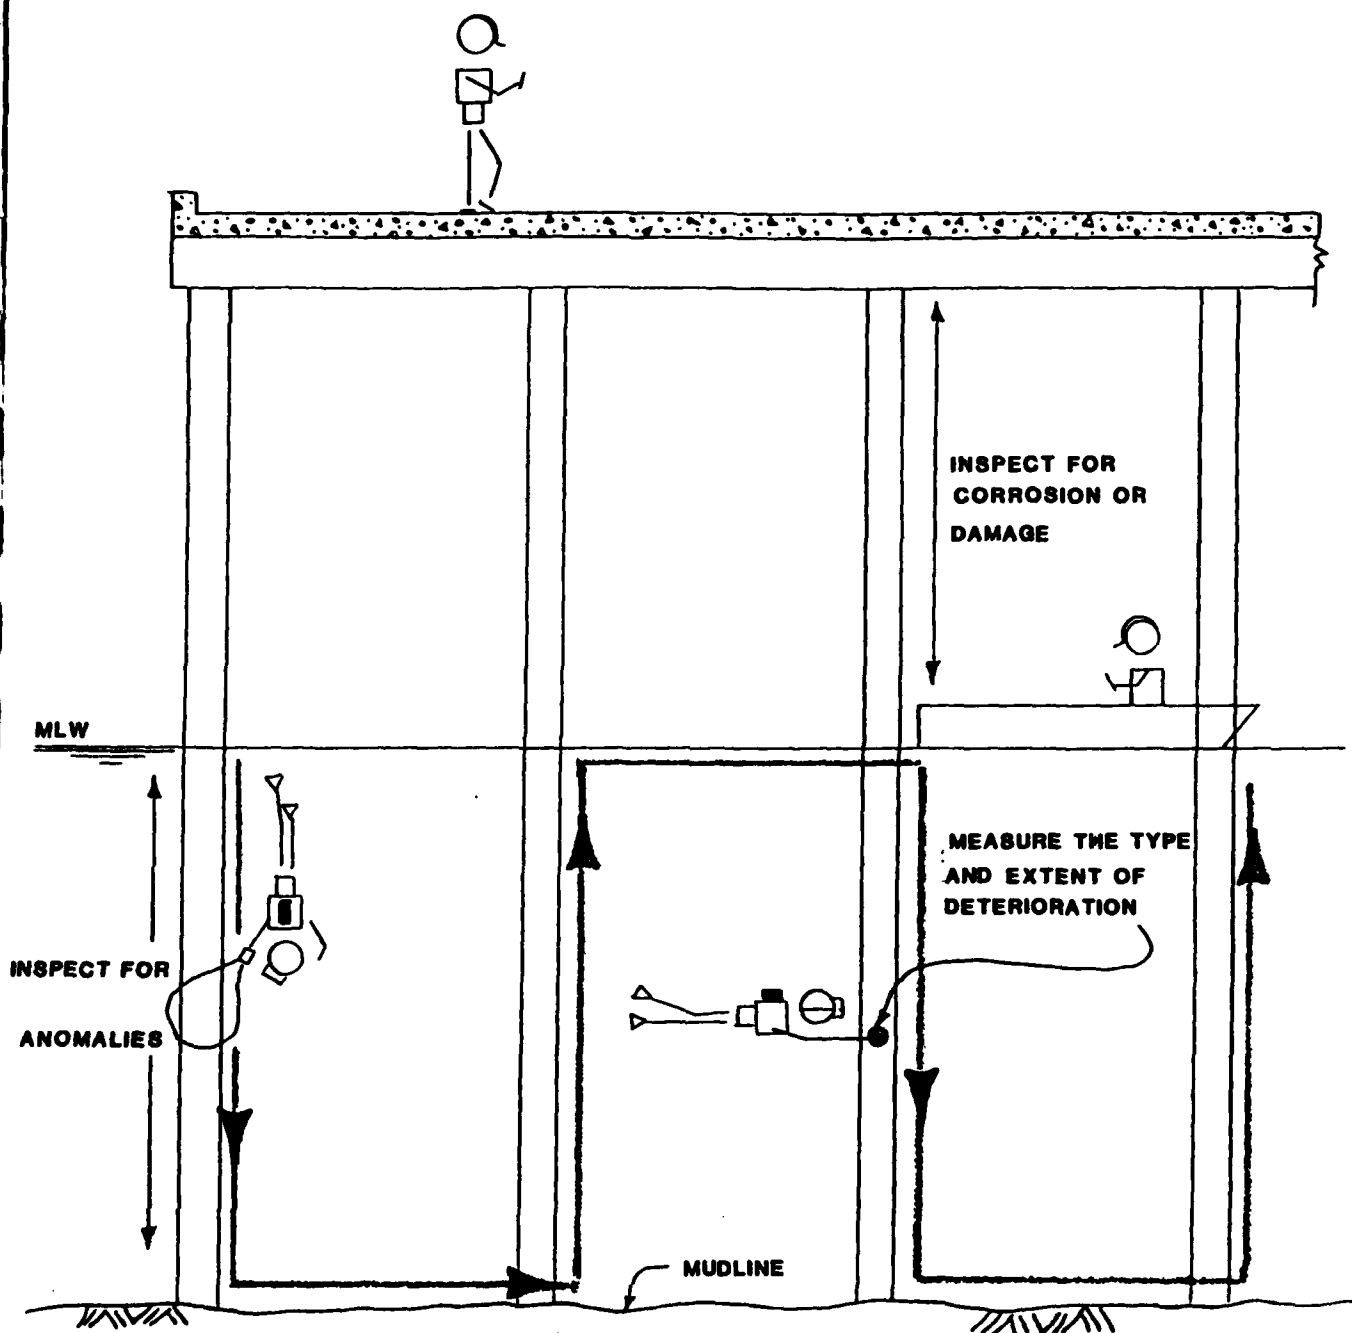
**TYPICAL DIVER INSPECTION PATH**

on the layout of the piles, divers would either inspect alternate bents or each take a portion of a bent. A minimum of 20% of the piles of each facility were closely inspected from the pile cap to mudline. The remainder of the piles were given a more cursory "swim-by" inspection, normally at mean low water as much of the damage or deterioration was seen in this area. Usually, every fifth bent was inspected closely in a manner similar to that depicted in Figure 2. Soundings were taken at intervals around the perimeter of each facility.

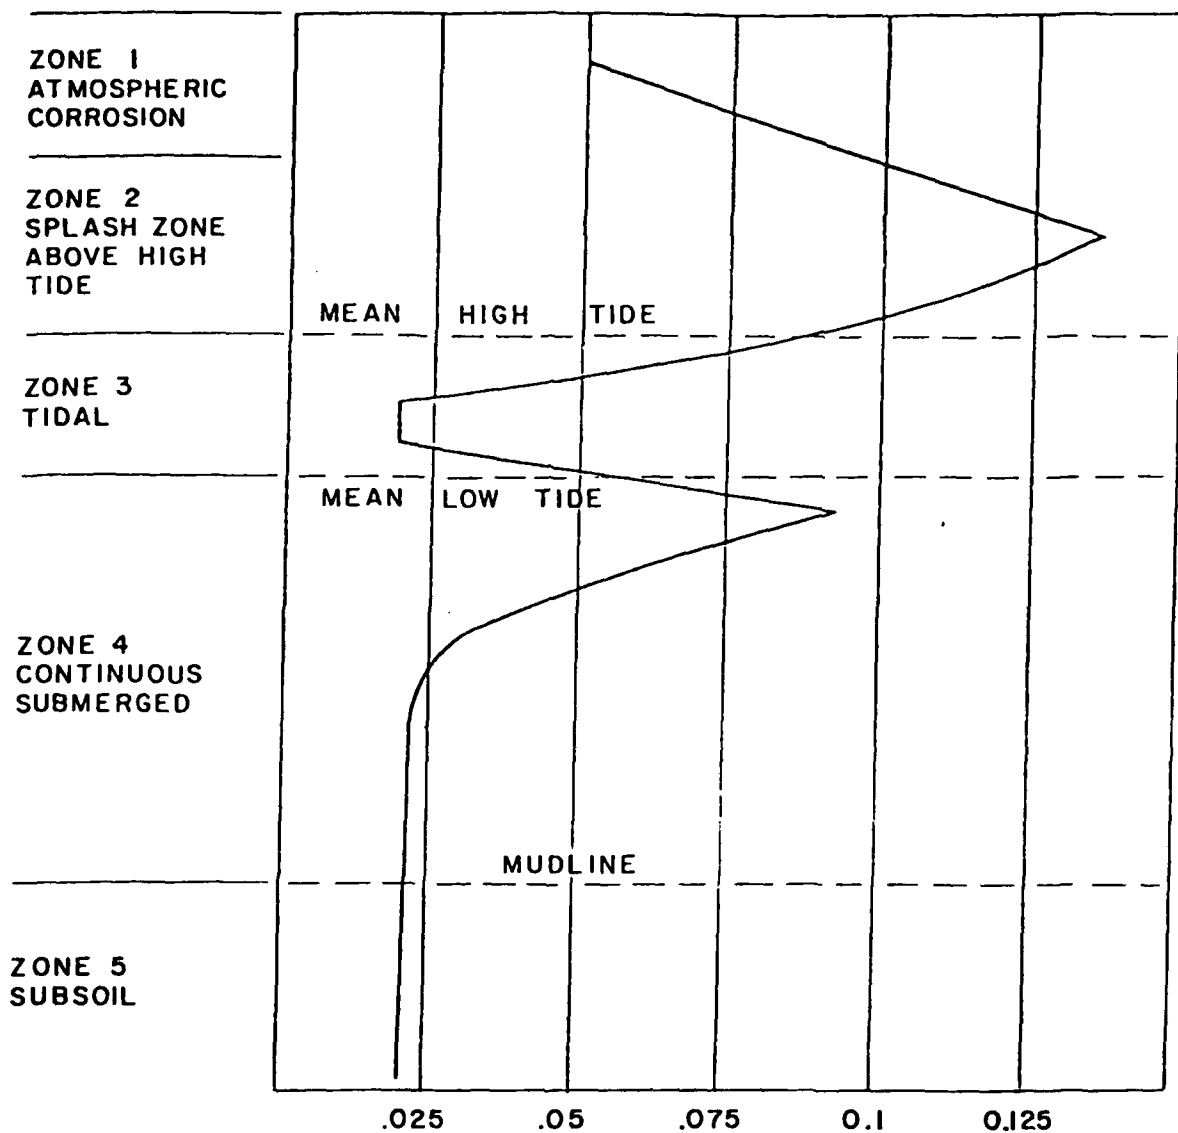
RELATIVE LOSS IN METAL THICKNESS  
CORROSION PROFILE OF STEEL PILING - FIVE YEARS EXPOSURE IN SEAWATER

For facilities with exposed steel piles, corrosion of the metal was an important concern. Based on classical corrosion curves, as shown in Figure 3, areas of maximum corrosion usually occur at or around mean low water (MLW), within 2 feet of the mudline, in the splash zone and in areas where a differential oxygen concentration cell is set up. This latter case can occur at the interface or boundary areas between concrete and steel. As a result, the steel adjacent to the concrete is sacrificed to protect the steel under the concrete.

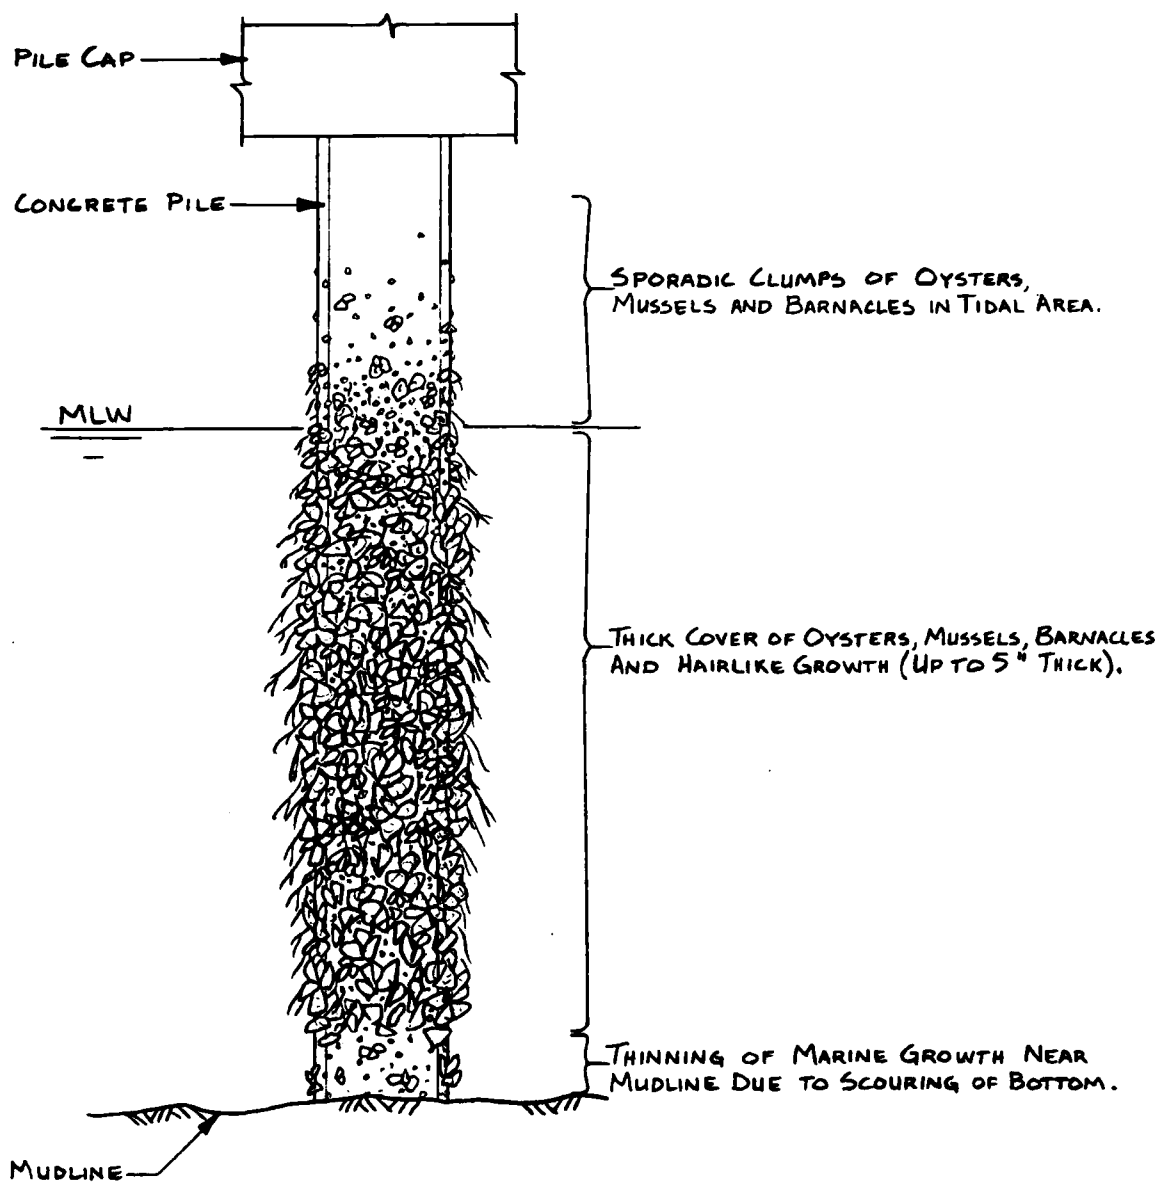
Marine growth profiles were noted for each facility. These profiles were similar for all the facilities at the Naval Station. In general, oysters, mussels and barnacles, along with a mat of hairlike growth covered both steel and concrete piles from mean low water to mudline (see Photo #1). Growth often thinned out within 6" - 12" of mudline, probably due to scouring. Oysters and the hairlike mat could be up to 4" - 5" thick in places, but averaged in thickness from 1" - 3". Growth thinned out above mean low water to sporadic clumps of small oysters and mussels and a scattering of barnacles, all of which ended in the splash zone. Figure 4 illustrates the general growth pattern.

GRAPHIC SCALE	Childs Engineering Corporation Box 338 Norfolk, VA	CHESAPEAKE DIVISION NAVAL FACILITIES ENGINEERING COMMAND WASHINGTON, D.C.	
NOT TO SCALE		NAVAL STATION <b>MARINE GROWTH PROFILE</b>	FILE NO. <b>4</b>

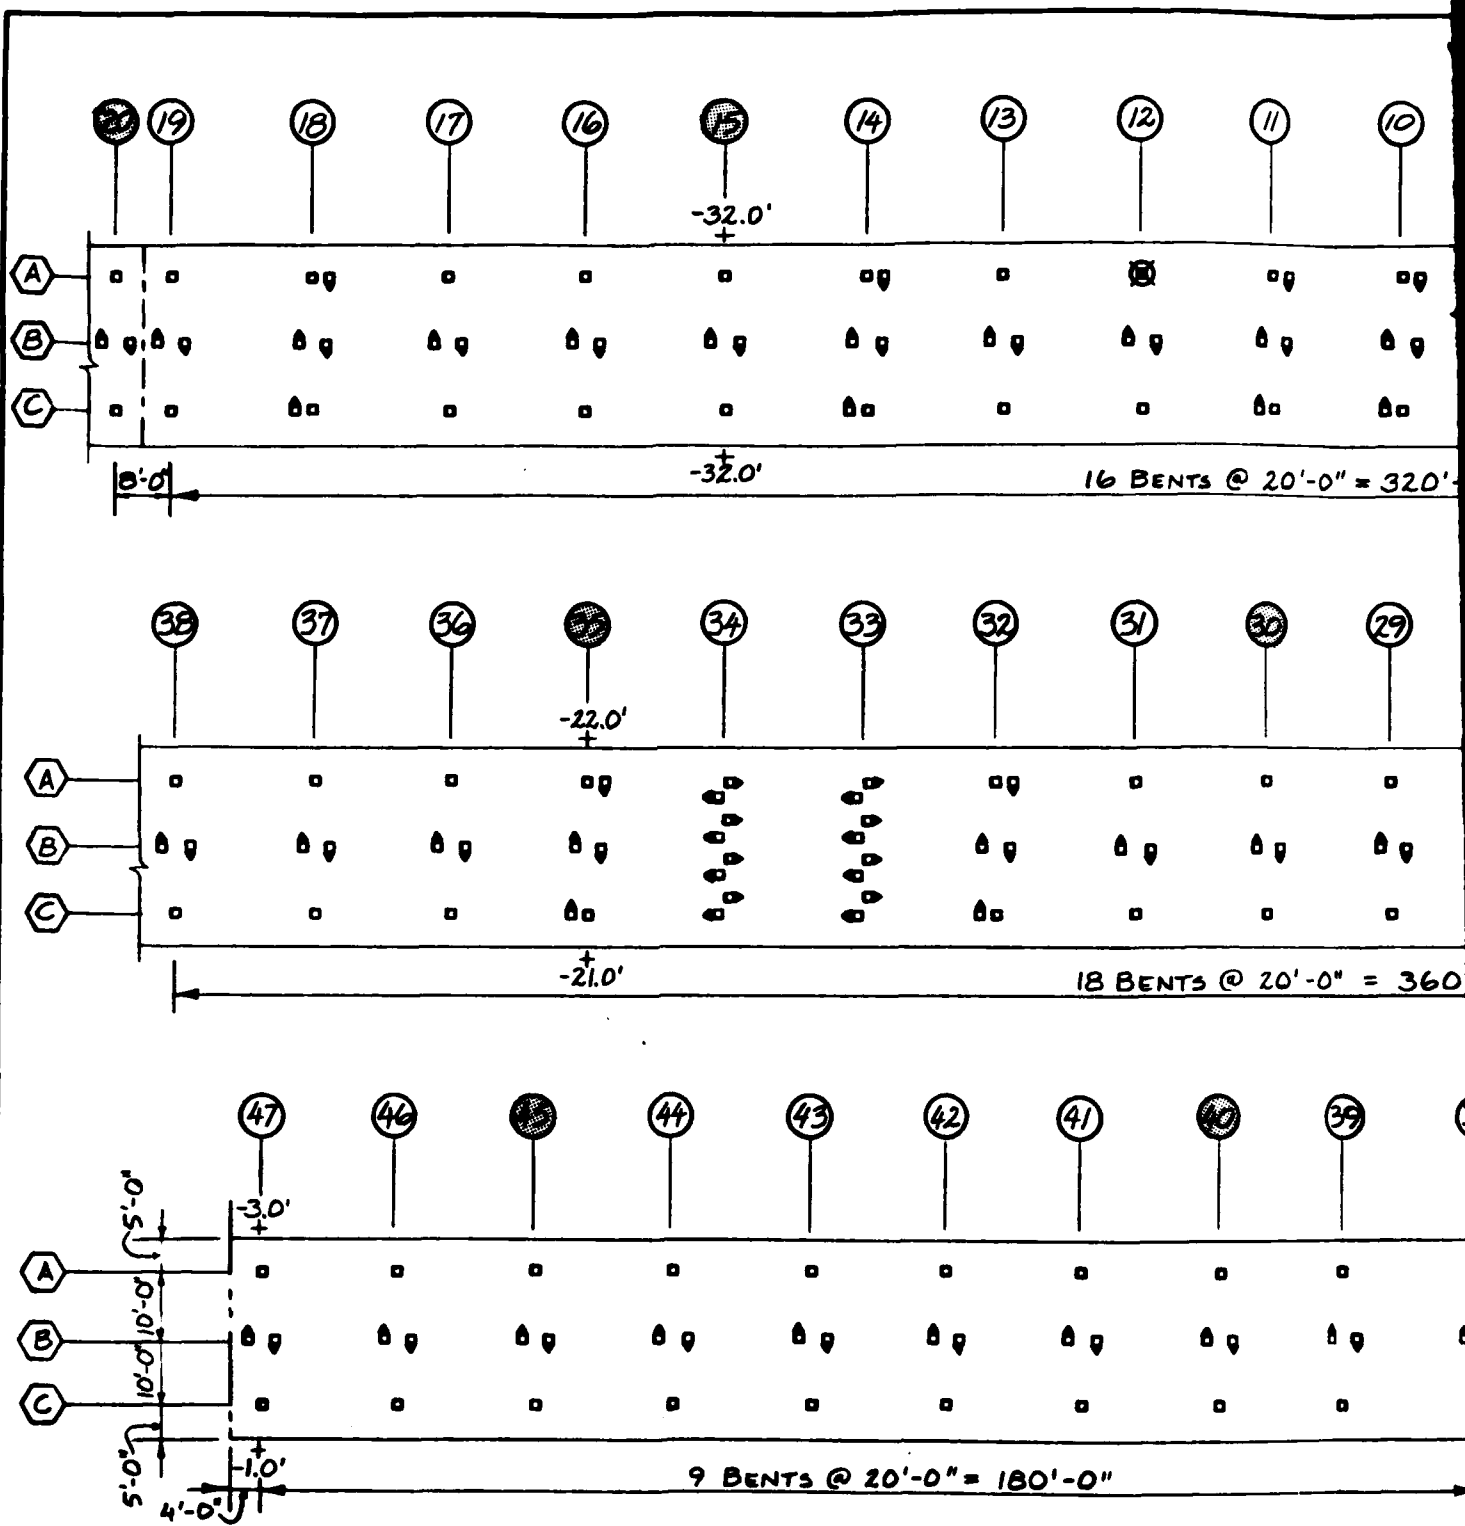
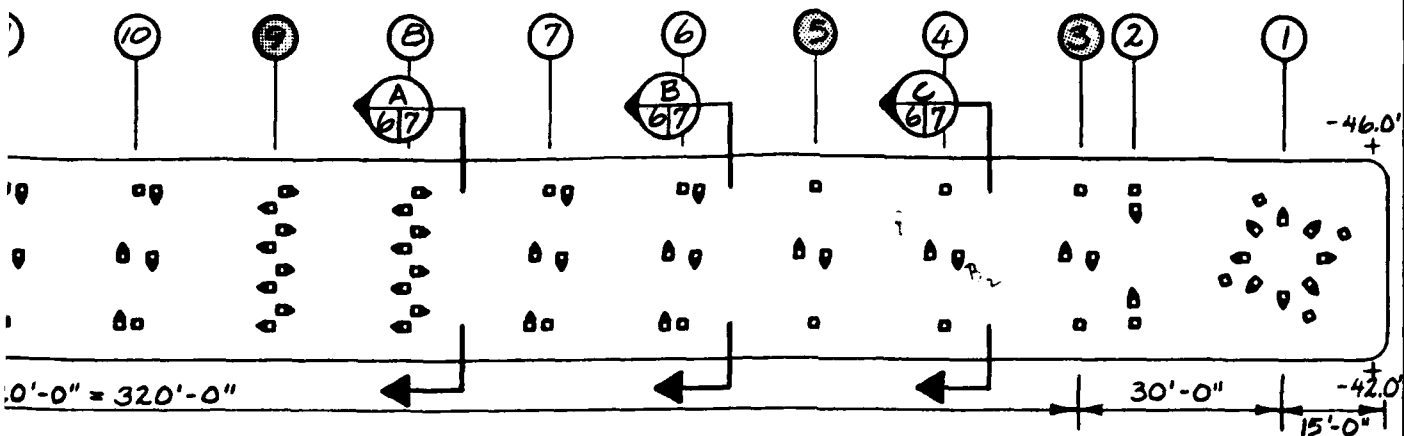
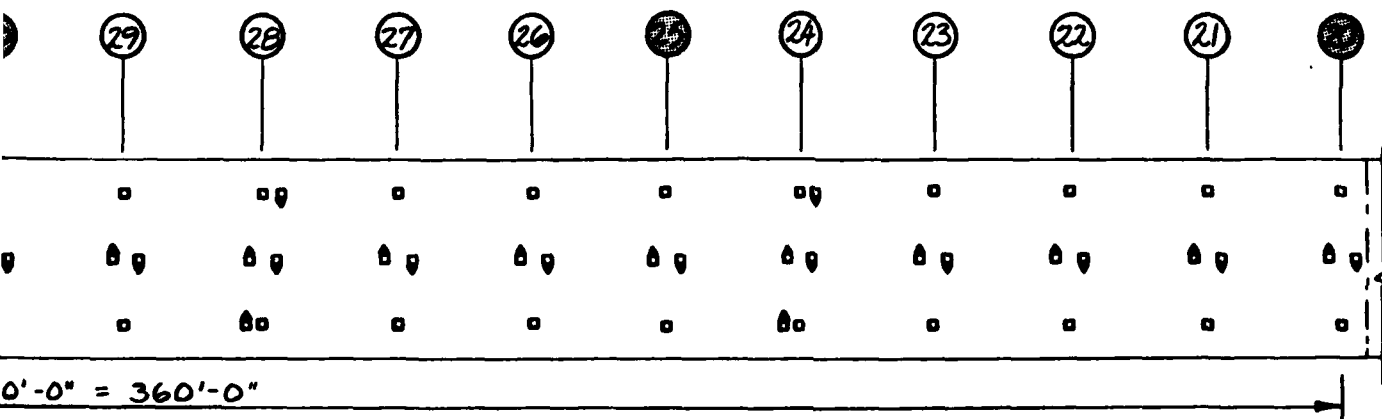
PLAN

- ③ BENT NO.
- ⬢ PILE DESIGNATION
- + -17.0' SOUNDING (MLW)
- ⑤ CLOSELY INSPECTED BENT. REMAINING BENTS GIVEN CURSORY "SWIM-BY" INSPECTION (SEE SECTION 3.2).
- ⊗ SIGNIFICANTLY DAMAGED PILE (SEE SECTION 4.1.2)

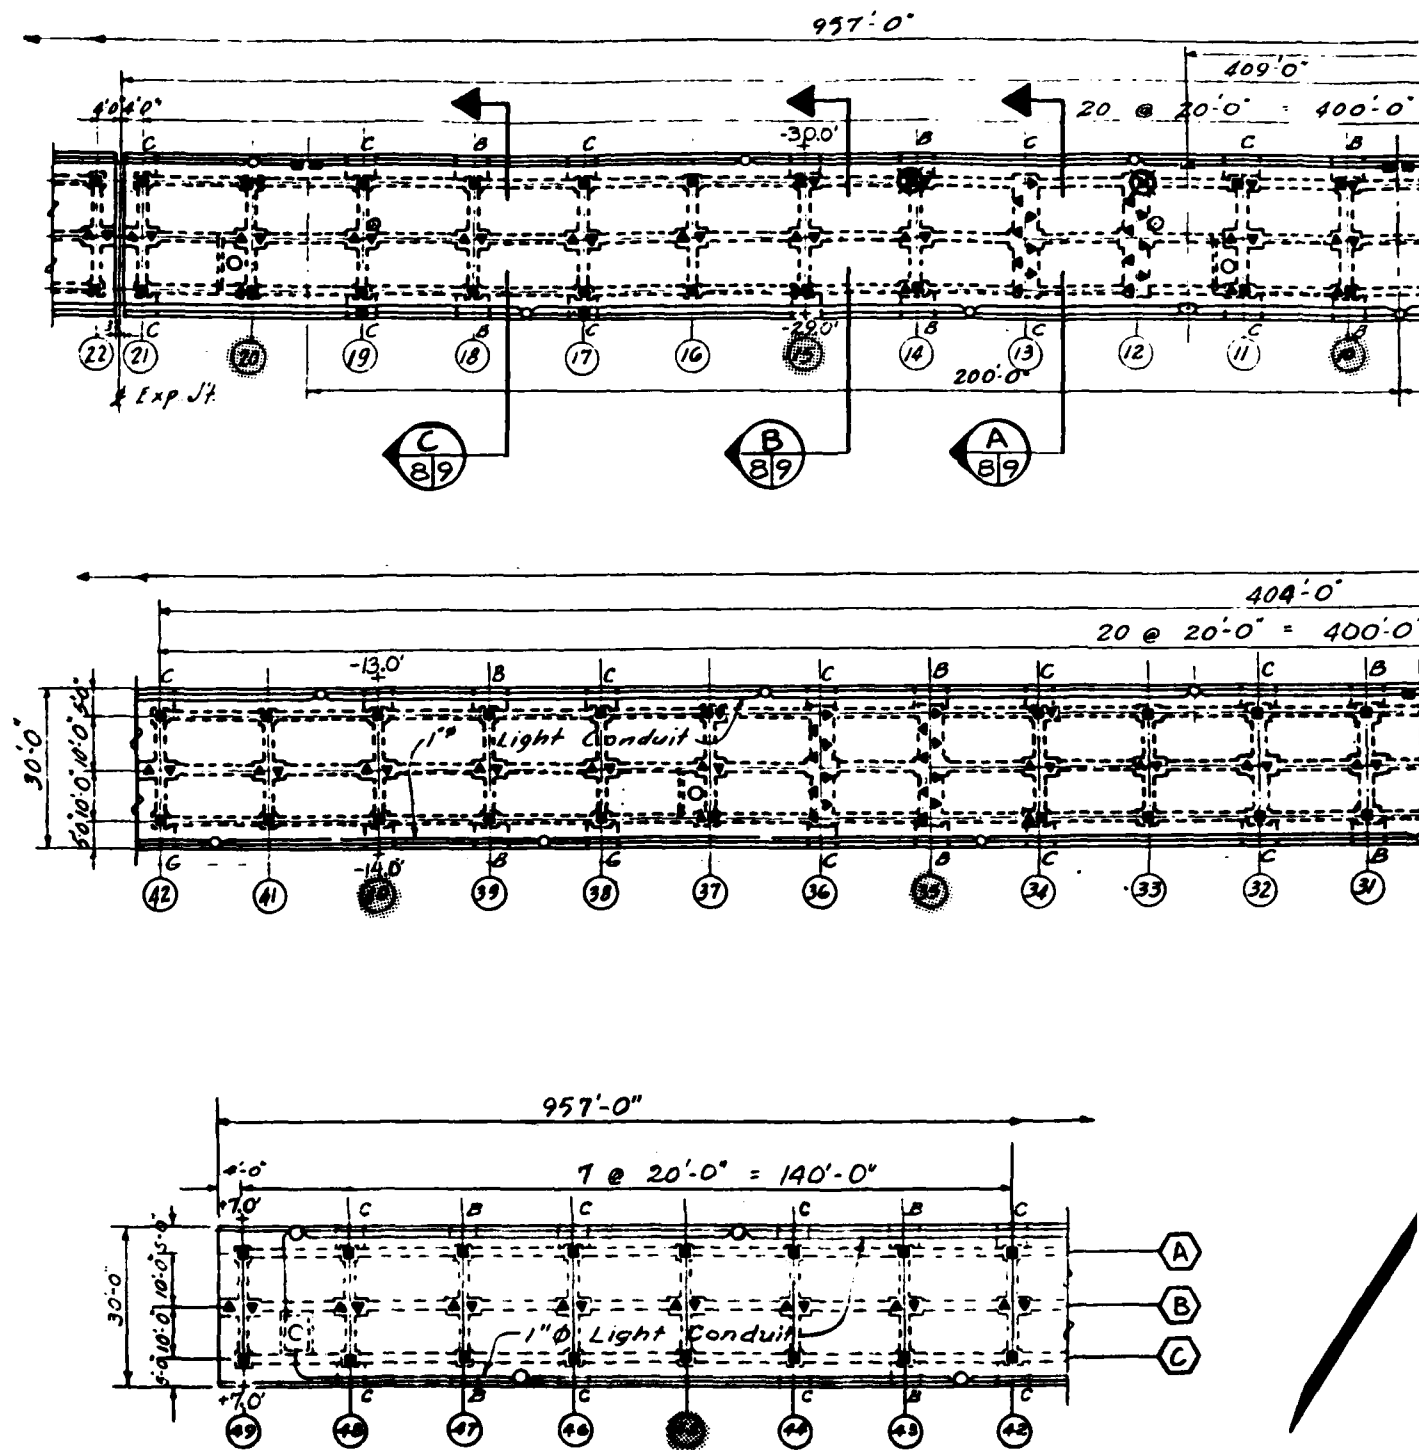
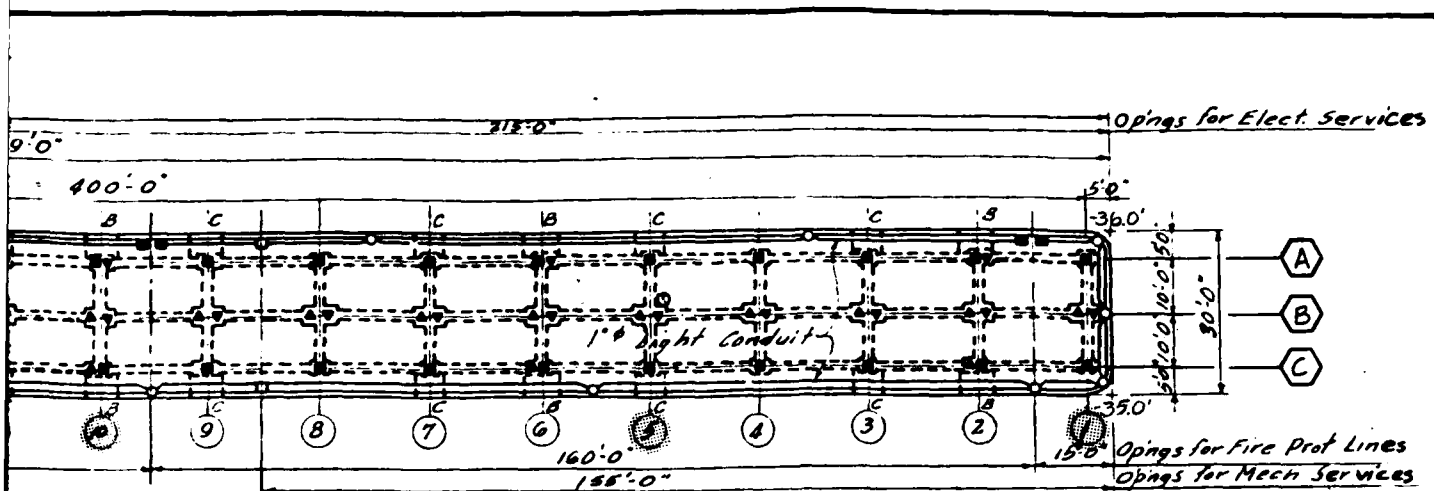
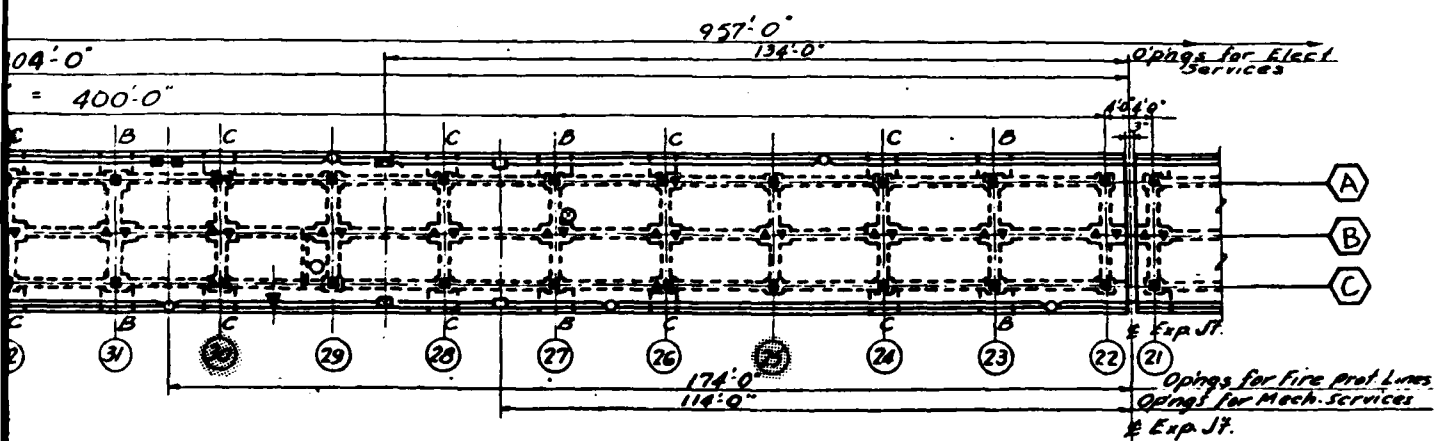
# **PLAN**

Pier LIMA was built in its present form around 1946. The 957' long x 30' wide pier is supported by 18" square precast, reinforced concrete piles (see Figure 8). There are 144 batter and 92 vertical bearing piles arranged in 49 bents which serve as foundation for the reinforced concrete deck (see Figure 9). In 1946, the pier design required a minimum bearing capacity of 50 tons for the piling and a deck live load of 300 PSF uniform load or H-15 loading plus 15% impact.

- (12) BENT NO.
- (A) PILE DESIGNATION
- +21.0' SOUNDING (MLW)
- VERTICAL PILE
- ▼ BATTER PILE
- ⊙ CLOSELY INSPECTED BENT. REMAINING BENTS GIVEN CURSORY "SWIM-BY" INSPECTION (SEE SECTION 3.2).
- ⊠ SIGNIFICANTLY DAMAGED PILE (SEE SECTION 4.2.2)

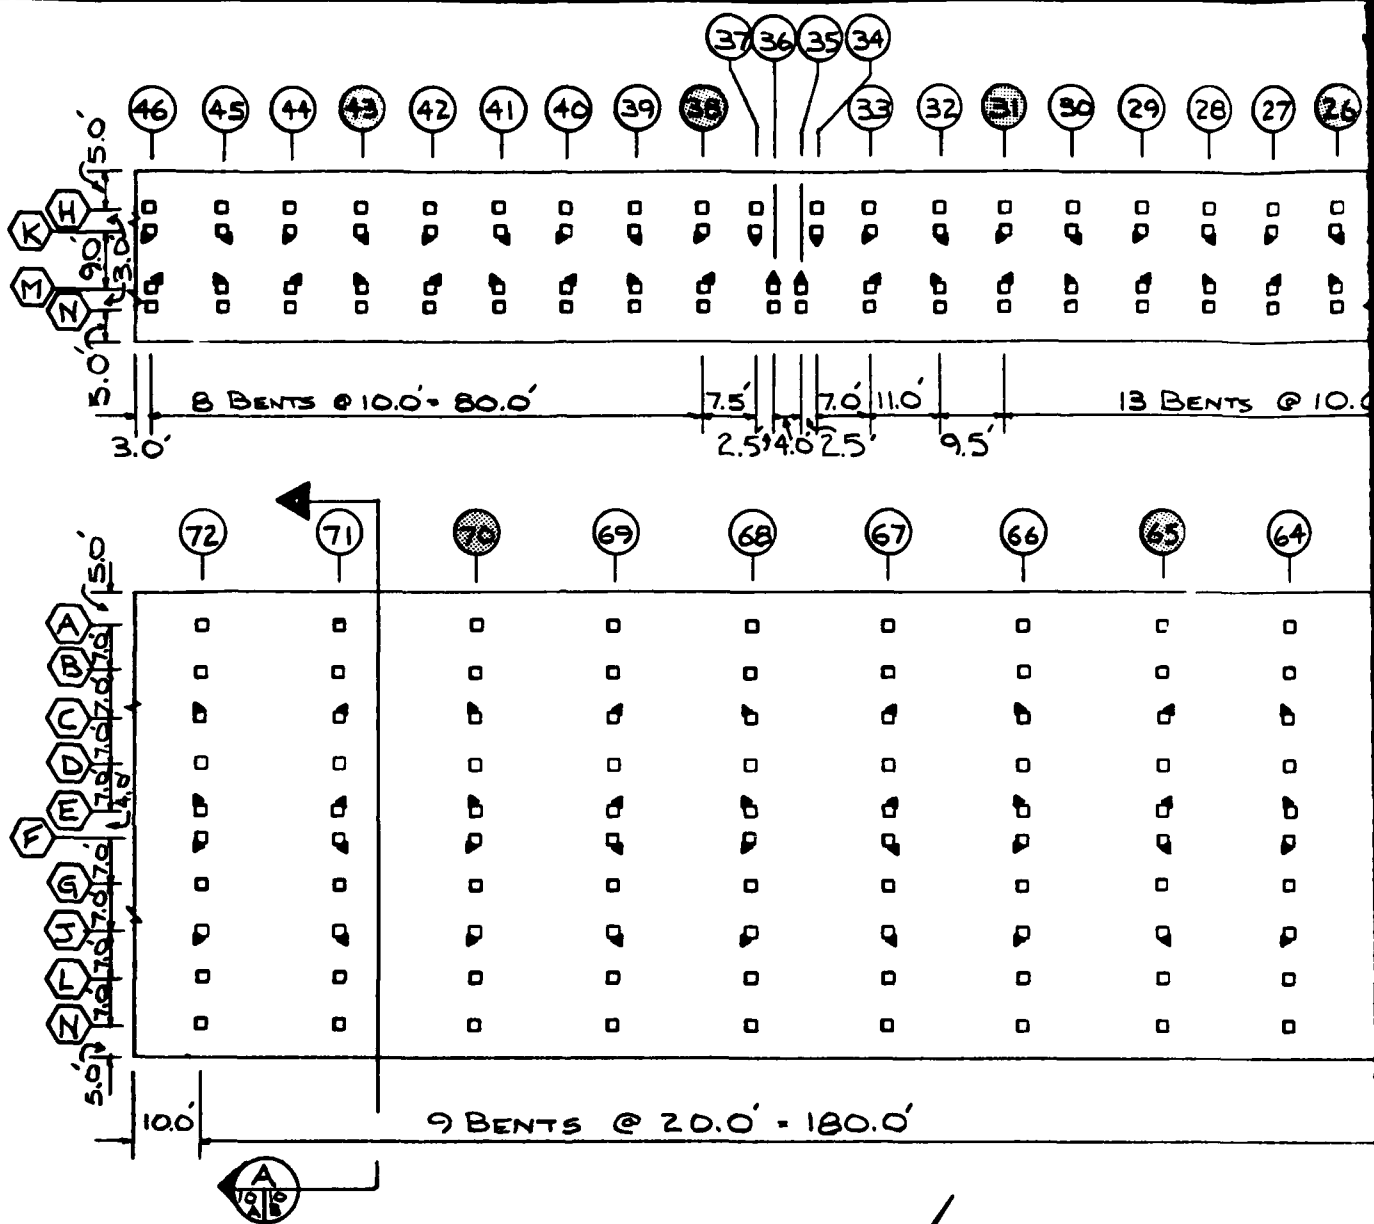
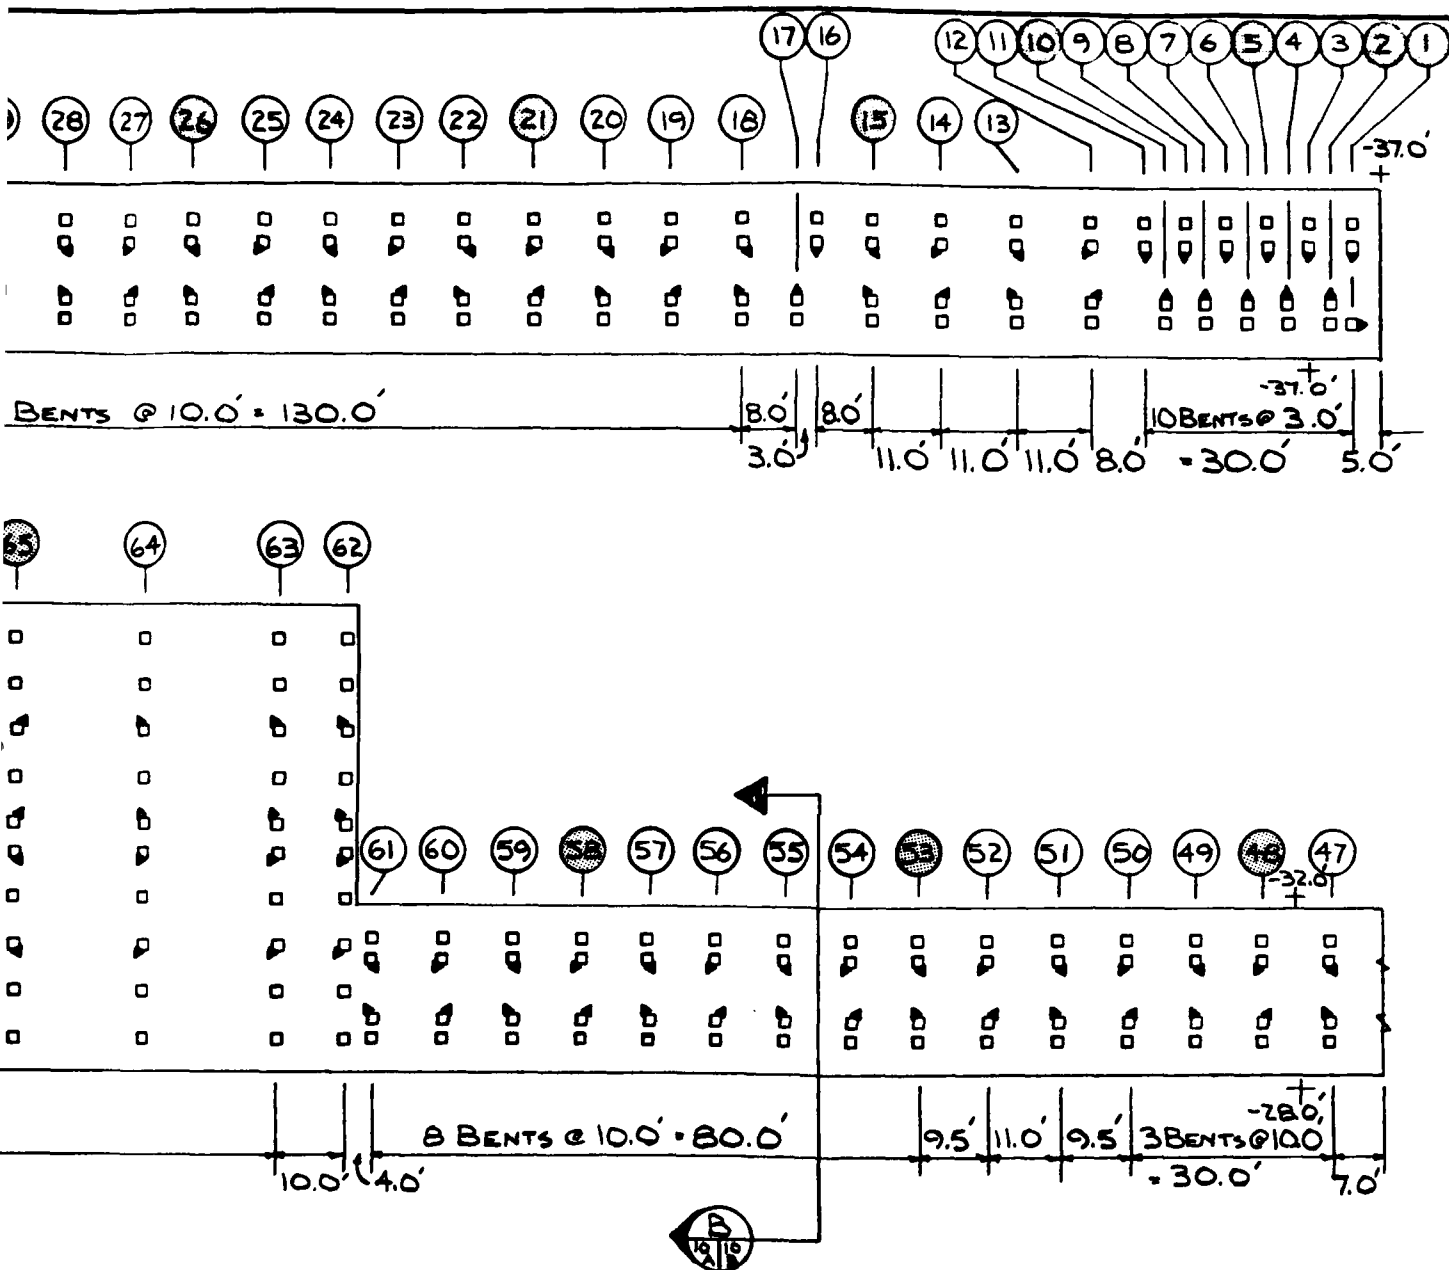
<p>GRAPHIC SCALE</p> <p>5' 0" 10' 20' 30' 40'</p>	<p>CNRS Engineering Corporation One 330 Bedford, MA</p>	<p>CHESAPEAKE DIVISION NAVAL FACILITIES ENGINEERING COMMAND WASHINGTON, D.C.</p> <p>NAVAL STATION CHARLESTON, SC</p> <p>PIER MIKE</p> <p>FIG. NO. 10A</p>
---	---	---

Pier MIKE was entirely rebuilt around 1975. It consists of a 600' long x 70' wide inboard section, 32 bents long, and a 500' long x 25' wide outboard section, 61 bents long, for mooring the AS. A total of 234 batter and 297 vertical bearing piles support the reinforced concrete decking. All piles are 18" square precast, reinforced concrete (see Figures 10A and 10B).

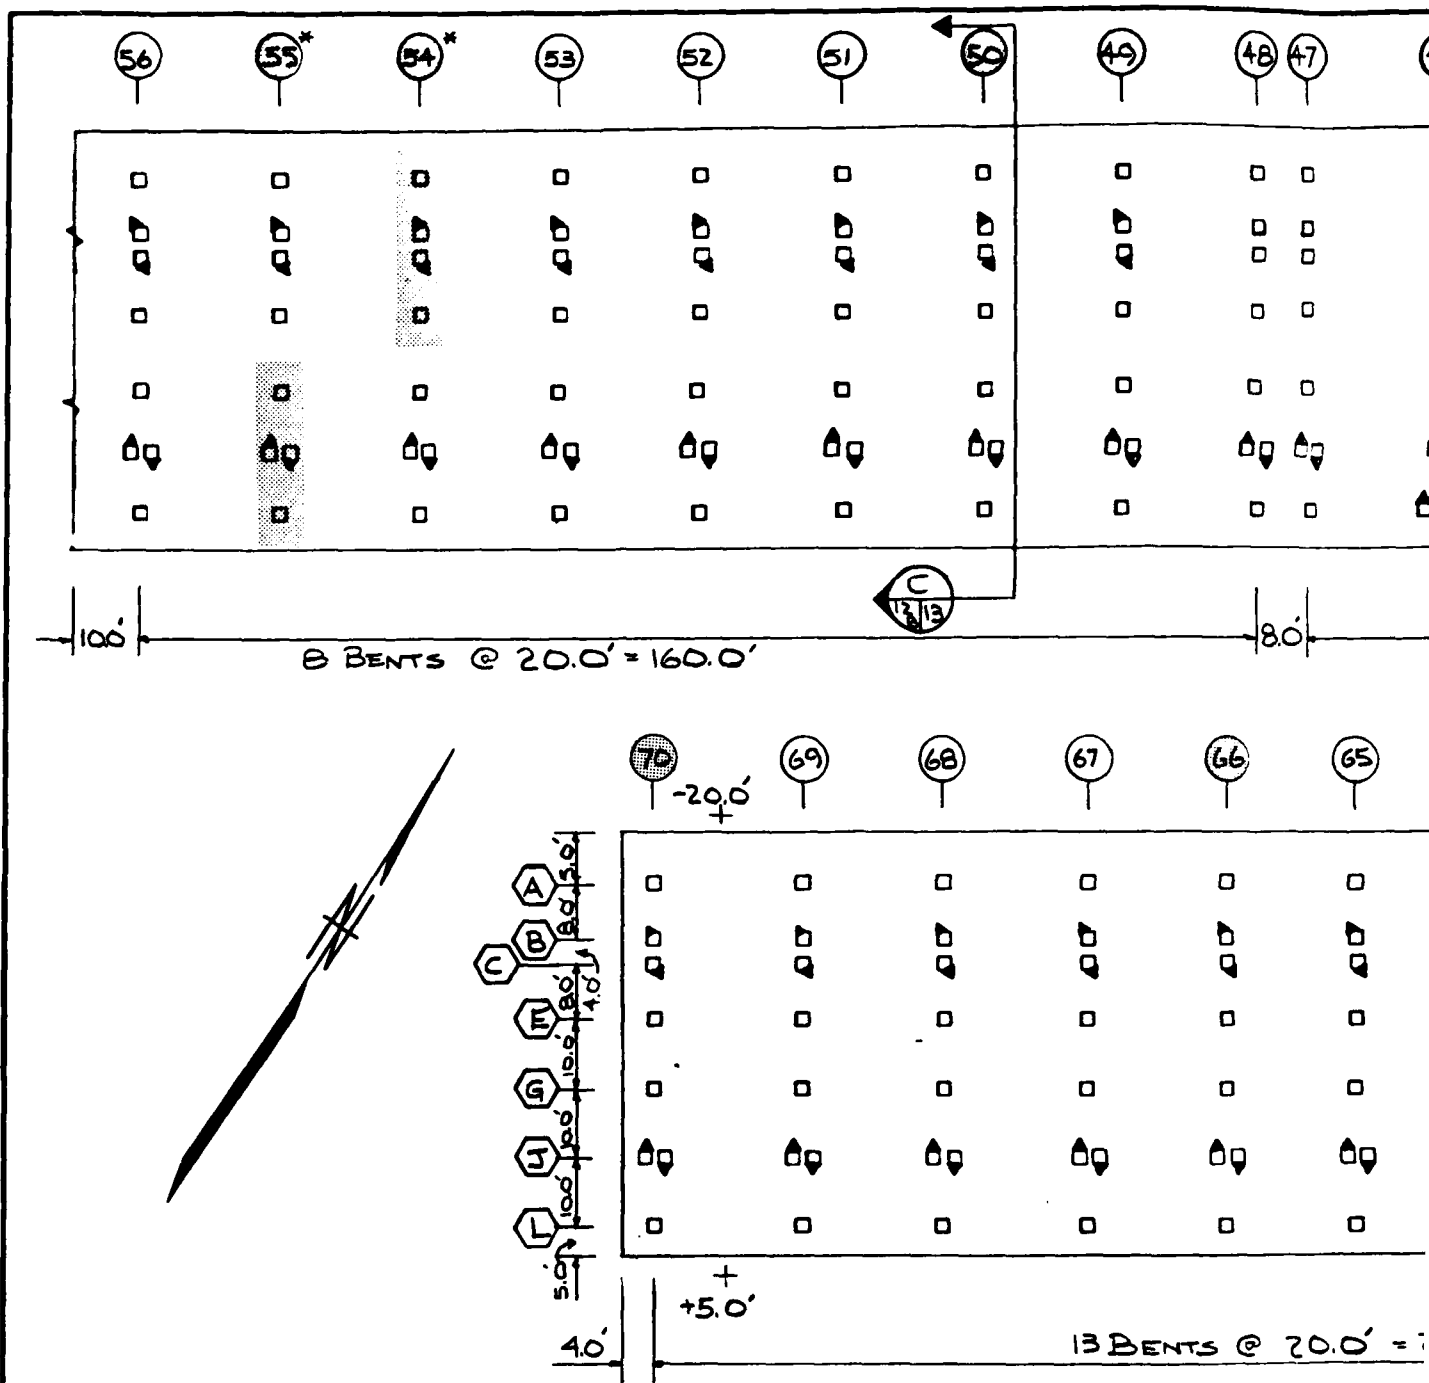
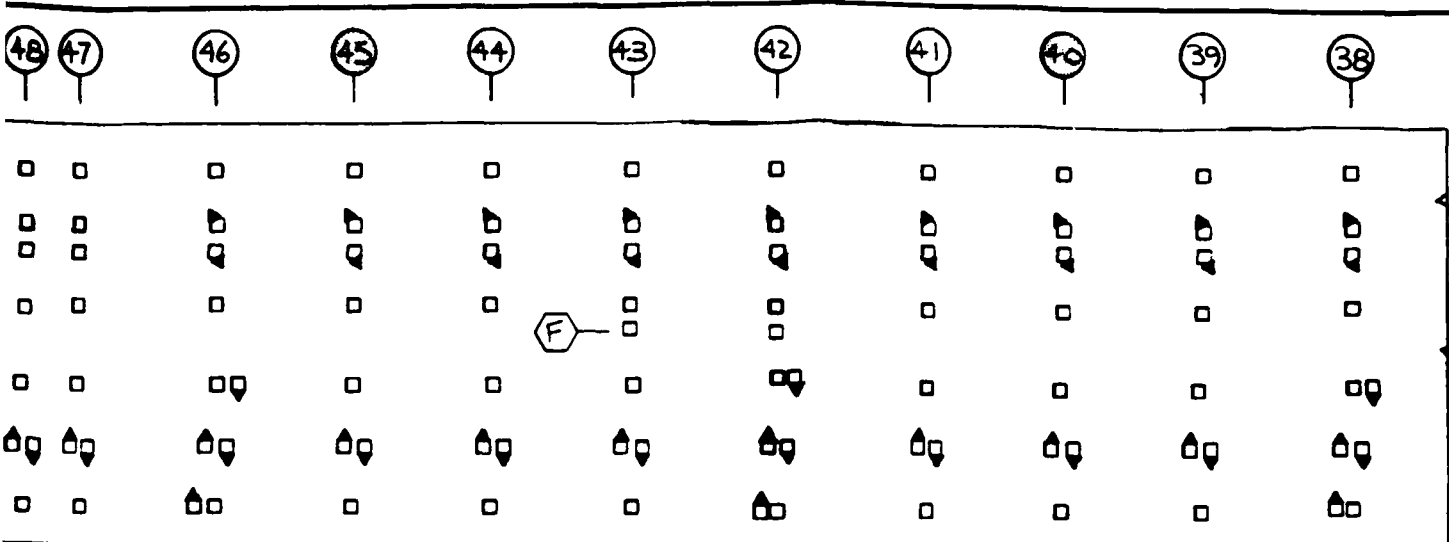
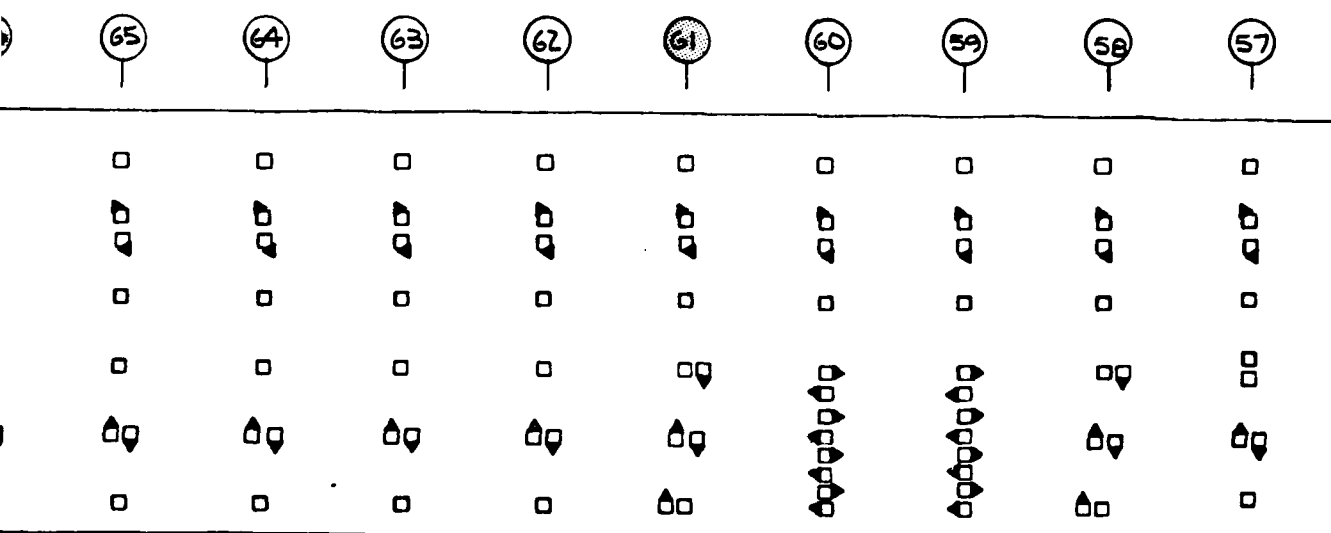
GRAPHIC SCALE	Childs Engineering Corporation Box 532 Marshfield, MA	CHESAPEAKE DIVISION NAVAL FACILITIES ENGINEERING COMMAND WASHINGTON, D.C.	
5' 0" 10' 20' 30' 40'		NAVAL STATION CHARLESTON, SC <b>PIER PAPA</b>	FIG. NO. <b>12B</b>

From Bents 20 to 70 of the pier, the piles exhibited cosmetic spalling on corners and some hairline cracking in the area from the pile cap to mean low water (MLW). Approximately 50% of the older piles had cracks up to 1/8" in width and softness up to 1" deep, in the area from MLW to mean high water. All the older piles had been patched around the pile head. There was some cracking and rusting around these patches and 10% had been spalled out (see Photo #8). The worst conditions were observed on Pile L in Bent 67. On one corner, a 1/4" crack ran from the pile cap to the mudline, and on another corner, an area within 6" of the pile cap was spalled 3" in. No rust or reinforcing was exposed, however.

The piles in the northern half of the pier were in better overall condition, with only 5% displaying cracking up to 1/8" in width. However, one pile had a 1/2" wide crack, 1" deep, from the pile cap down 3 feet (no reinforcing exposed), and three piles were spalled up to 3" deep on one or two faces within 2 feet of the pile cap, exposing steel reinforcing.

Nine piles from Bents 1 to 19 exhibited spalling, up to 3" deep, on up to two corners or faces within 3 feet of the pile cap. Six of the nine piles had reinforcing exposed. The remainder of the piles had occasional cosmetic spalling on the corners.

Pier PAPA is in good condition. No structural anomalies were observed to cause this pier to be downgraded. As for many concrete piles of similar age, cracking and spalling of the concrete was the most common deterioration recorded. Although generally not a structural problem, minor cracking and spalling allow salt water to enter the pile. This ingress of water often hastens deterioration. Repairs to stop this continuing infiltration of water are the only solution.

It is recommended that all cracks greater than 1/32" in width and spalled areas deeper than 1" be filled with an epoxy grout. Before filling, these areas should be chipped and replaced, if necessary. The estimated cost to repair this pier is \$51,000.
